# Inspection Report

123 Whisper Lane  
Ocean NJ 07763

**Integrity Home Inspection Services Group LLC.**

<b>Date:</b> 2/20/2017	<b>Time:</b> 12:00 PM	<b>Report ID:</b> 052917
<b>Property:</b> 123 Whisper Lane Ocean NJ 07763	<b>Customer:</b> Mrs. Lisa Johnson	<b>Real Estate Professional:</b>

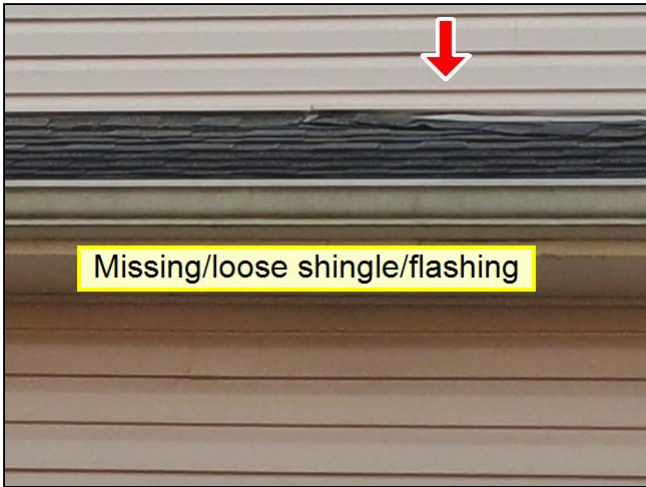
1.1 Item 1(Picture) Garage side siding

(1) Above Garage overhang- Shingles/Flashing material observed missing and loose. Recommend a NJ Registered Roofing Contractor repair and/or replace necessary shingle/ flashing. Failure to do so may result in water leaking into structure ultimately cause water damage to structure.

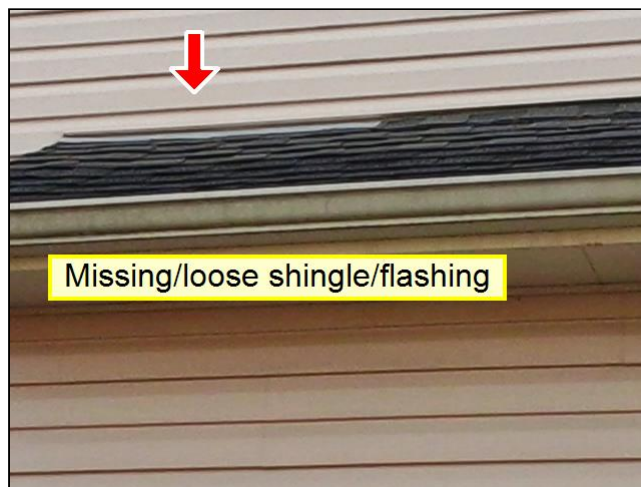
1.1 Item 2(Picture)

(2) Above Garage overhang- Shingles/Flashing material observed missing and loose. Recommend a NJ Registered Roofing Contractor repair and/or replace necessary shingle/ flashing. Failure to do so may result in water leaking into structure ultimately cause water damage to structure.

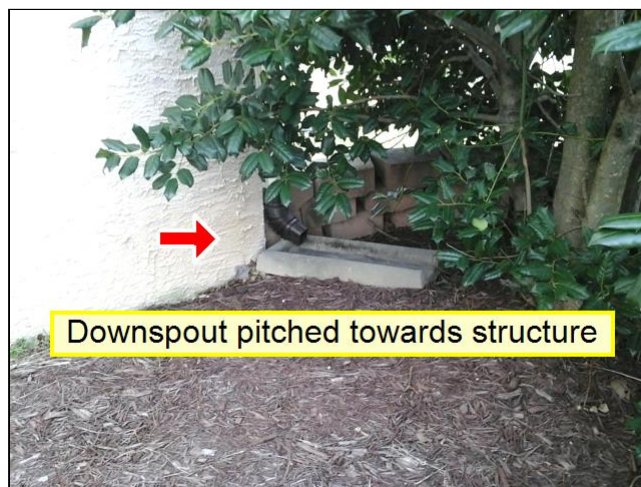
1.4 Item 1(Picture) Front Downspout

Front Right side of Structure- downspout pitched (leaning backwards) towards house. This is causing water to be diverted towards structure. Existing decorative brick structure has collapsed due to water diversion. Recommend that a NJ Registered Contractor reposition downspout to allow water to divert away from structure and repair decorative brick structure. Failure to do so will continue to cause decorative brick structure to collapse and ultimately pose a threat to water entering structure.

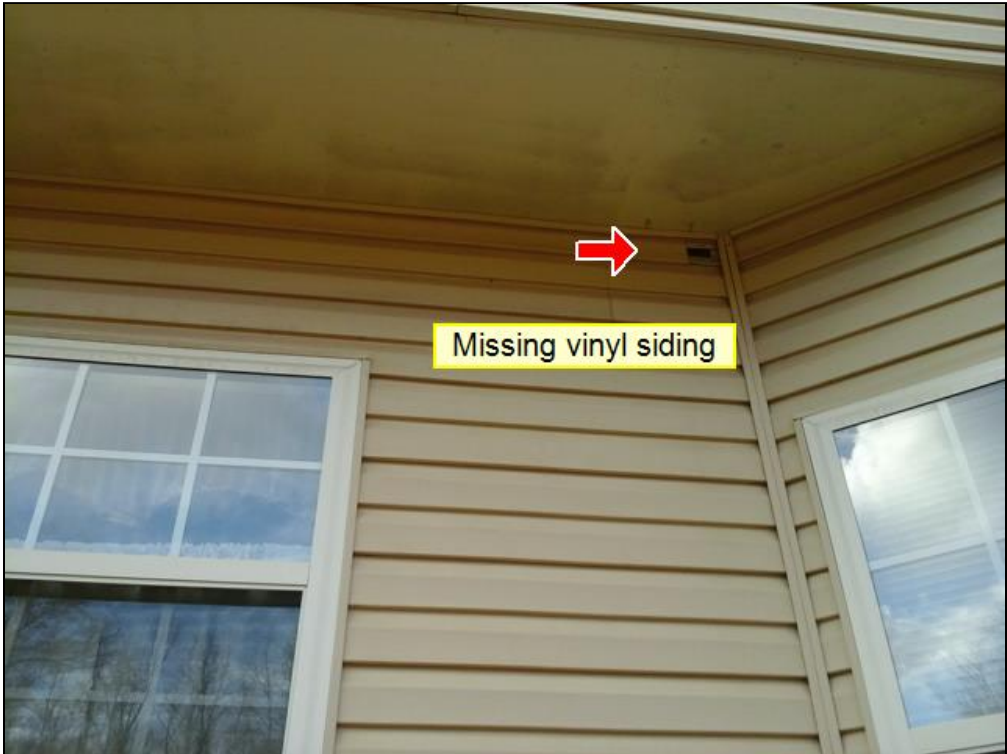
2.0 Item 1(Picture) Missing siding

Rear top of structure had missing piece of vinyl siding. Recommend NJ Registered contractor inspect and replace missing siding portion. Failure to do so will result in moisture getting behind siding and ultimately causing damage to structure possibly in form of rot or mold.

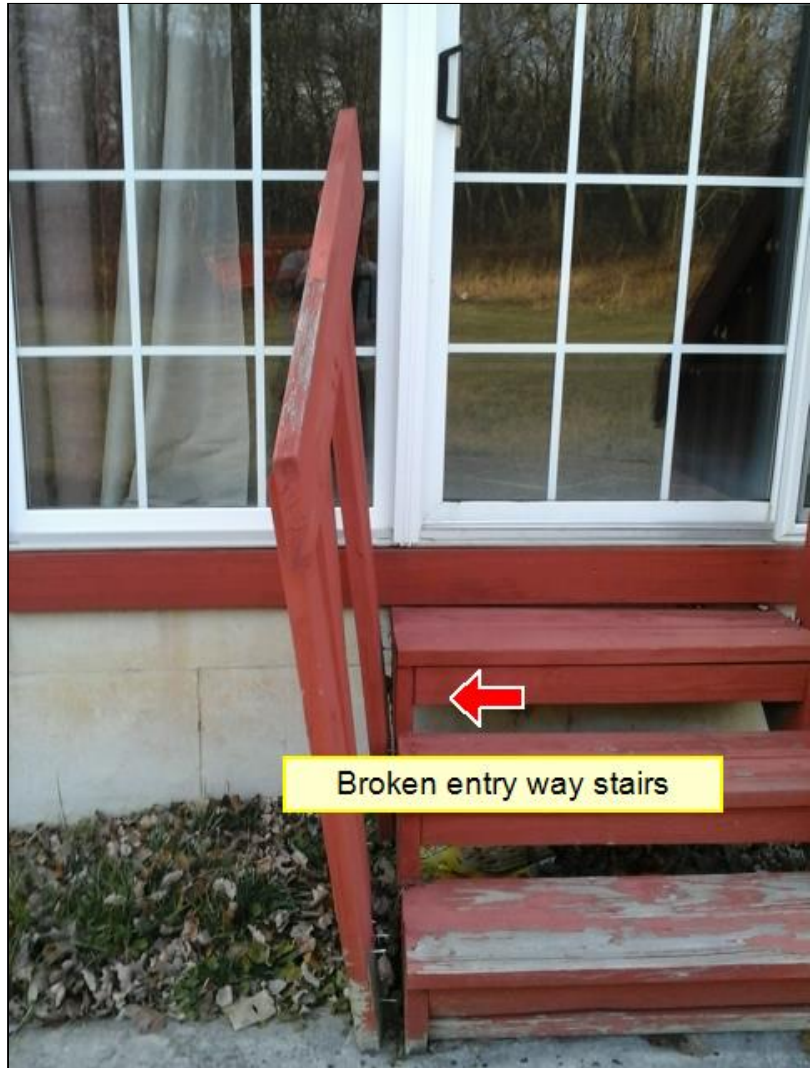
2.3 Item 1(Picture) Rear Steps

(1) Rear of structure had broken stairs into/exiting of home. HIGHLY Recommend at NJ Registered contractor repair/replace stairs. Failure to do WILL result in bodily harm. This is a MUST to do prior to using rear sliding door as an entry or exit mode.

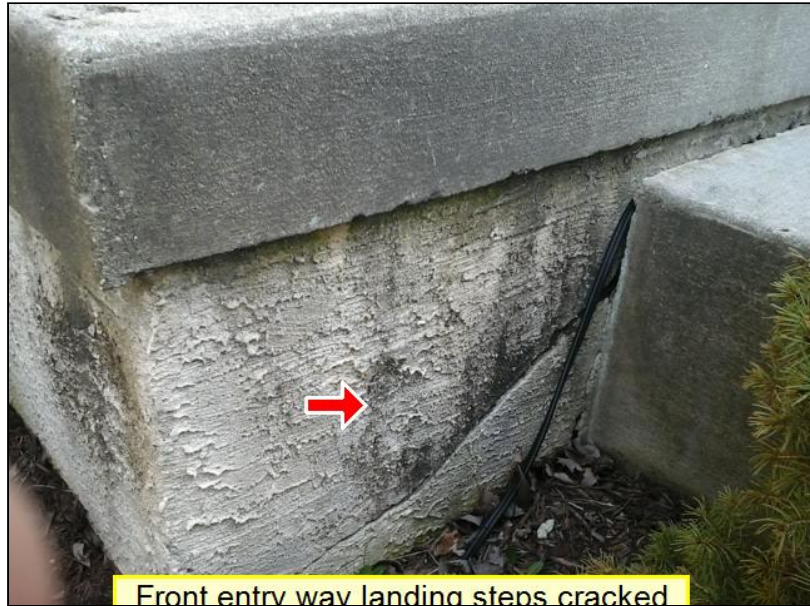
2.3 Item 2(Picture) Cracked Foundation

(2) Entry way steps/landing of structure cracked. Highly recommend a NJ Registered contractor make necessary repairs to steps/landing. Failure to do so may result in ultimate collapse of steps and could cause bodily harm to individuals. In addition, will allow moisture to potentially enter structure.

Front entry way landing steps cracked

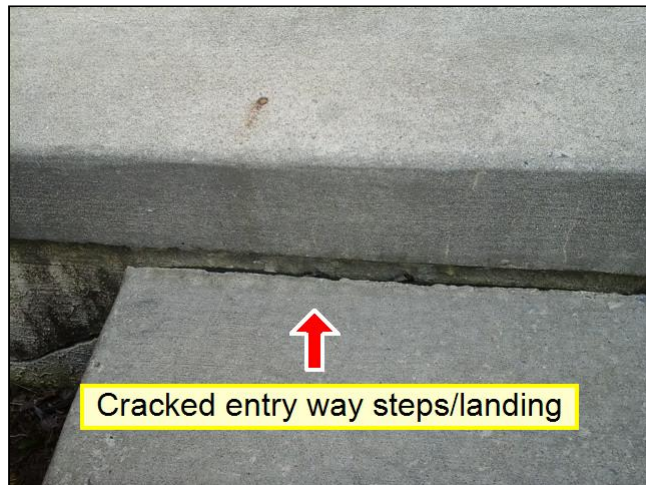
(3) Entry way steps/landing of structure cracked. Highly recommend a NJ Registered contractor make necessary repairs to steps/landing. Failure to do so may result in ultimate collapse of steps and could cause bodily harm to individuals. In addition, will allow moisture to potentially enter structure.

Cracked entry way steps/landing

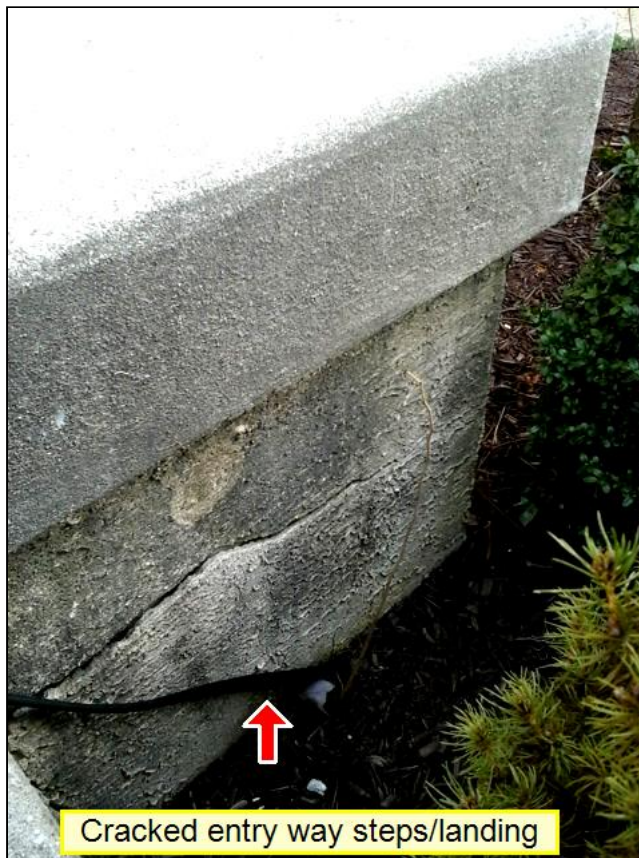
2.3 Item 4(Picture) Front Steps

(4) Entry way steps/landing of structure cracked. Highly recommend a NJ Registered contractor make necessary repairs to steps/landing. Failure to do so may result in ultimate collapse of steps and could cause bodily harm to individuals. In addition, will allow moisture to potentially enter structure.

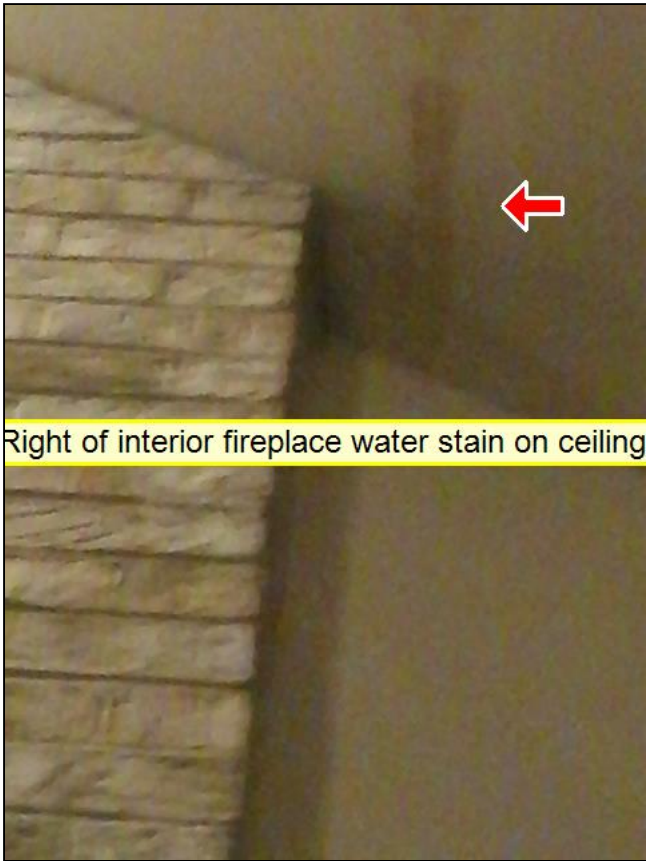
(1) Interior Fireplace right side on ceiling showed signs of water staining. Highly recommend that a NJ Registered Contractor examine cause of water stain and make necessary repairs. Failure to do so my result in additional staining and possible water damage to other parts of the structure.

Right of interior fireplace water stain on ceiling

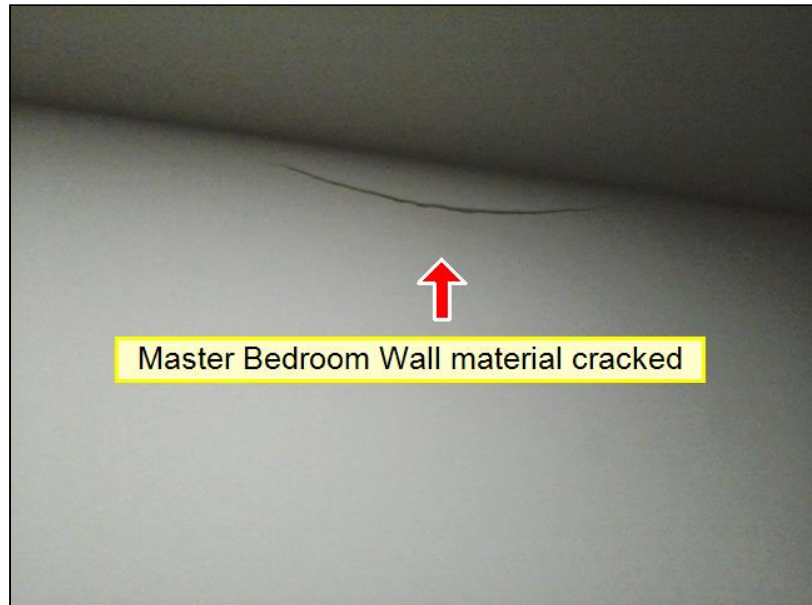
5.0 Item 2(Picture) Master Bedroom Ceiling

(2) Upstairs master bedroom wall has cracked drywall near ceiling. Highly recommend a NJ Registered Contractor examine cause of crack and make necessary repairs/ replacement. Failure to do so may result in further damage to wall or structure.

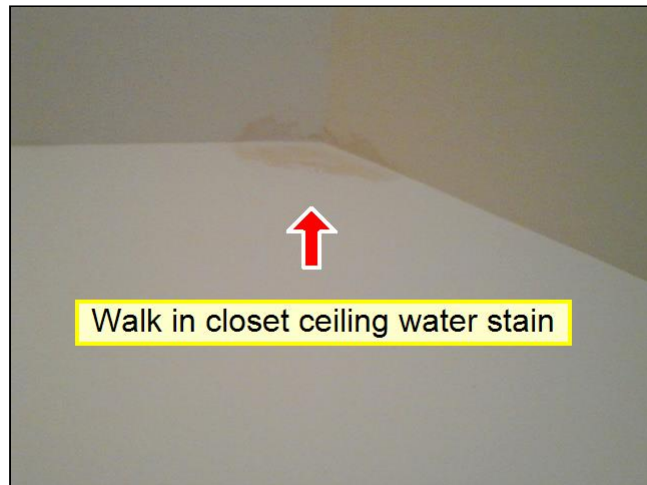
5.0 Item 3(Picture) Walk in Closet

(3) Upstairs walk in closet ceiling showed signs of water stain. Highly recommend a NJ Registered Contractor examine cause of crack and make necessary repairs/ replacement. Failure to do so may result in further damage to wall or structure.

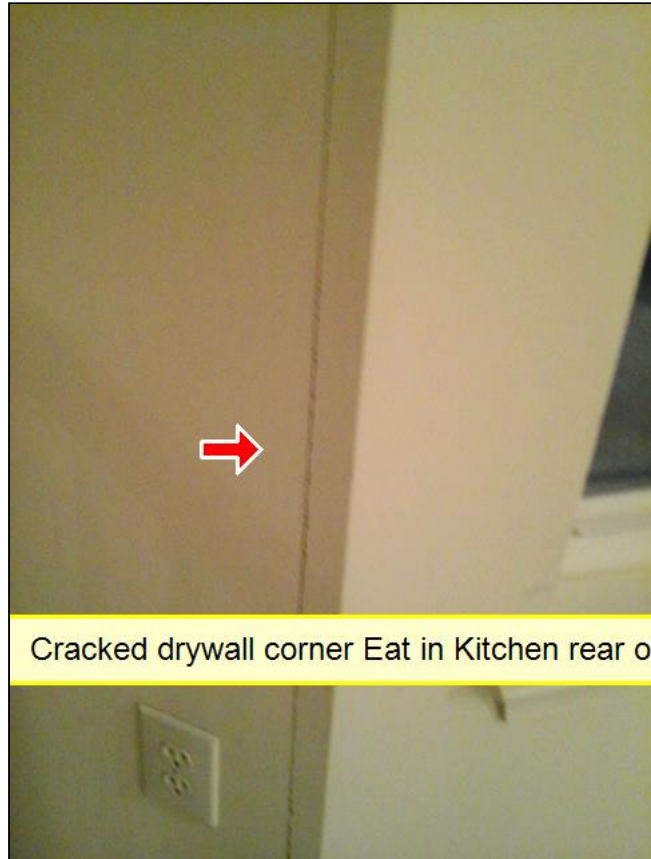
5.1 Item 1(Picture)

Drywall in Eat in Kitchen wall corner observed. Recommend a NJ Licensed Contractor examine and make necessary repairs to crack. Failure to do so may result in further cracking or structural damage to visibly unknown/unseen causes of crack.

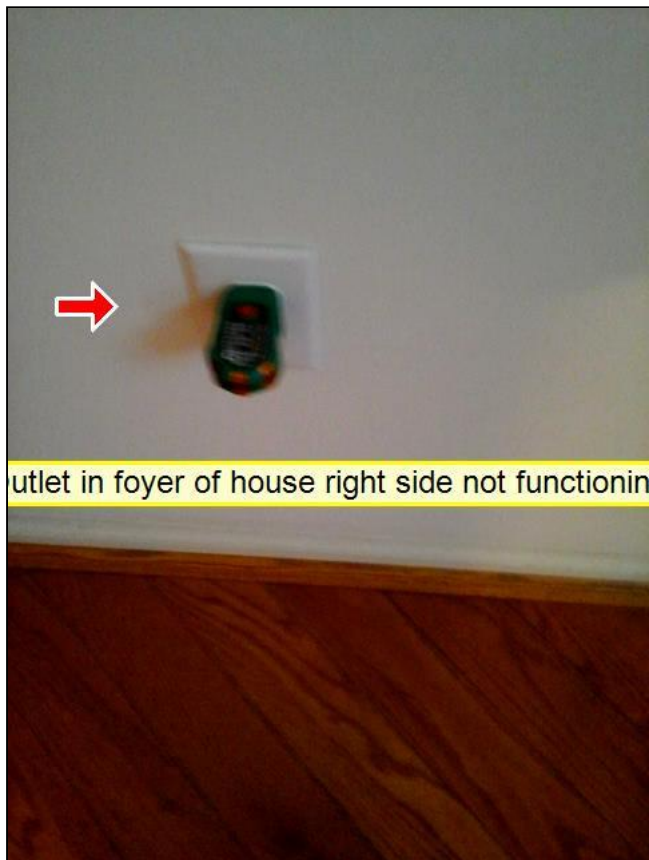
5.6 Item 1(Picture) Foyer Outlet

Outlet in foyer of structure not operational. Recommend a NJ Licensed Electrical Contractor repair/replace outlet. Failure to do so will cause lack of convenient use of outlet.

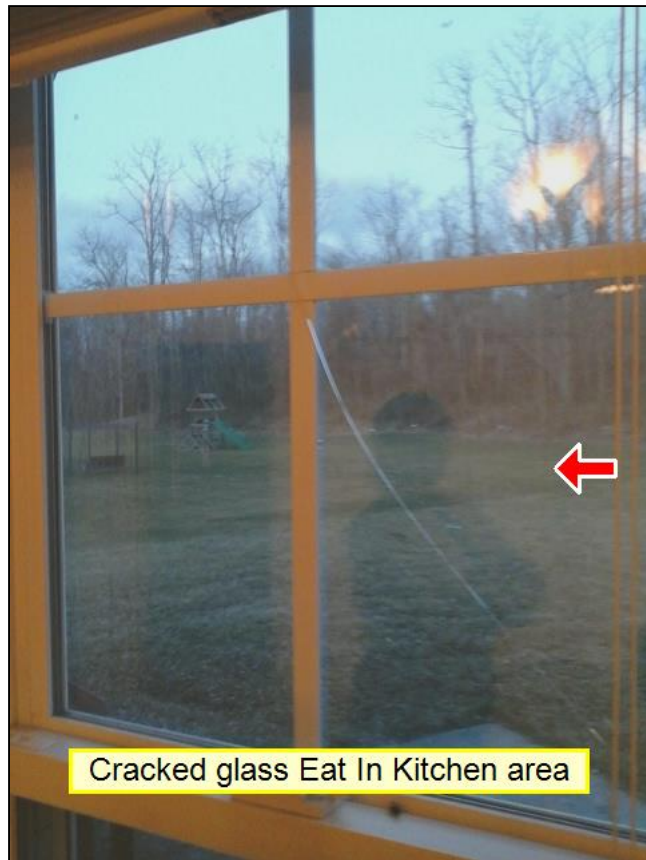
6.2 Item 1(Picture) Cracked glass in Kitchen

Cracked glass panel in eat in kitchen window. Recommend a NJ Registered contractor replace window/window glass. Failure to do so may result in glass cracking more and or bodily harm if glass cuts an individual.

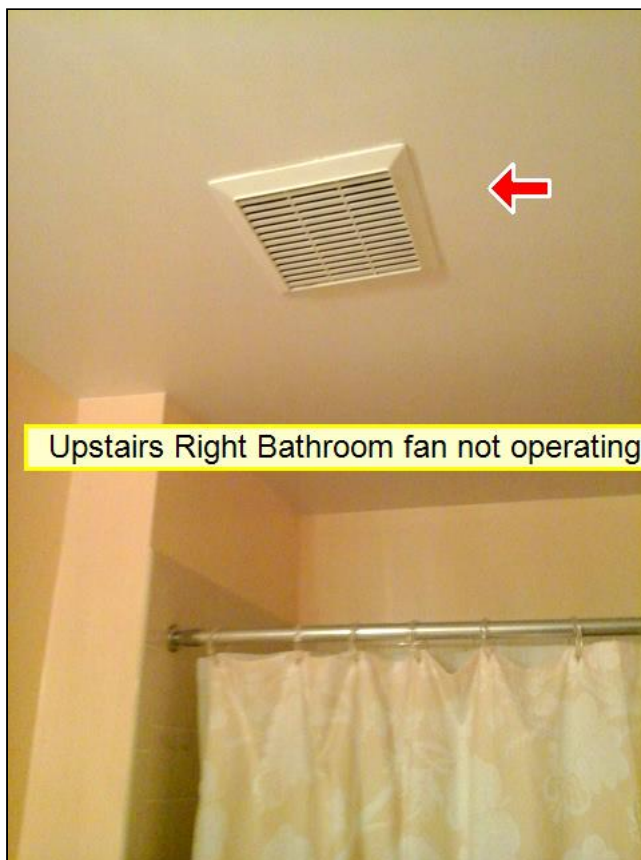
6.6 Item 1(Picture) Bathroom Fan

Upstairs Right bathroom not operating. Recommend a NJ Licensed Electrical Contractor make necessary repairs. Failure to do so will result in moisture from shower not being vented out of structure ultimately leading to possible mold development.

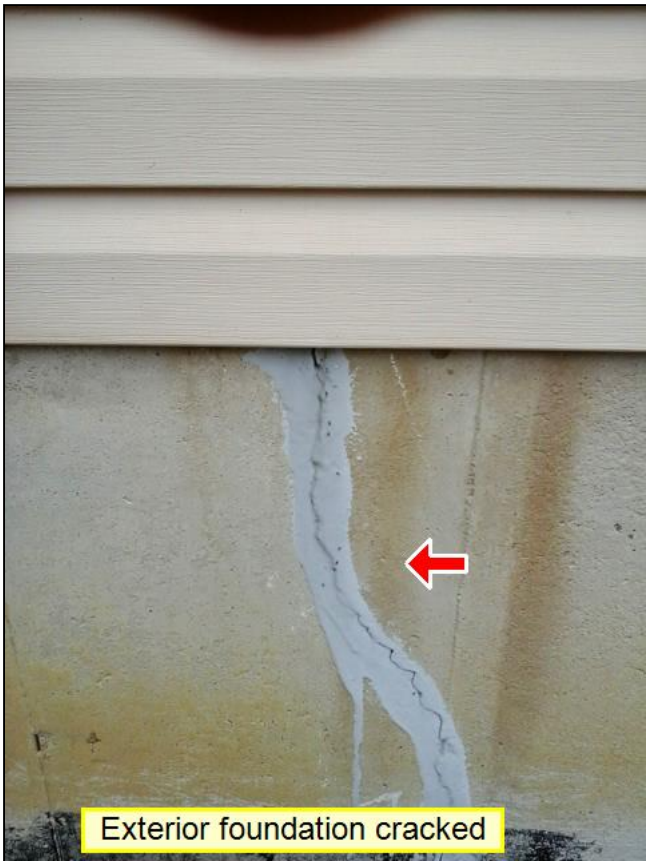
7.0 Item 1(Picture) Basement wall crack

(1) Exterior foundation of structure cracked. Repairs have been made to crack. HIGHLY recommend a NJ Registered Structural Engineer examine crack/repairs to determine structural integrity. Failure to do so may result in structural failure and or bodily harm to individual in the cause of a foundation failure. This is a MUST DO.

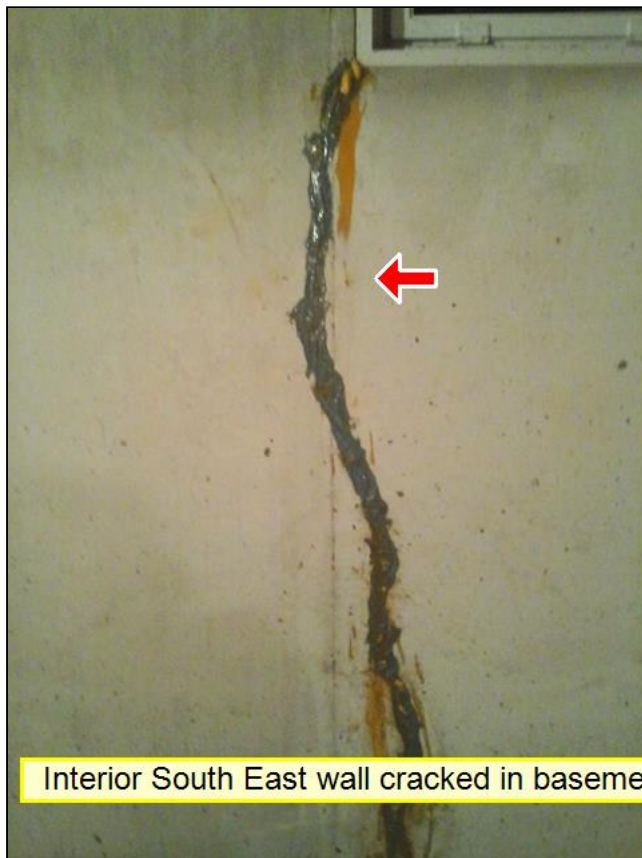
7.0 Item 2(Picture) Basement Wall Crack

(2) Interior basement wall cracked. Repairs have been made to crack. HIGHLY recommend a NJ Registered Structural Engineer examine crack/repairs to determine structural integrity. Failure to do so may result in structural failure and or bodily harm to individual in the cause of a foundation failure. This is a MUST DO

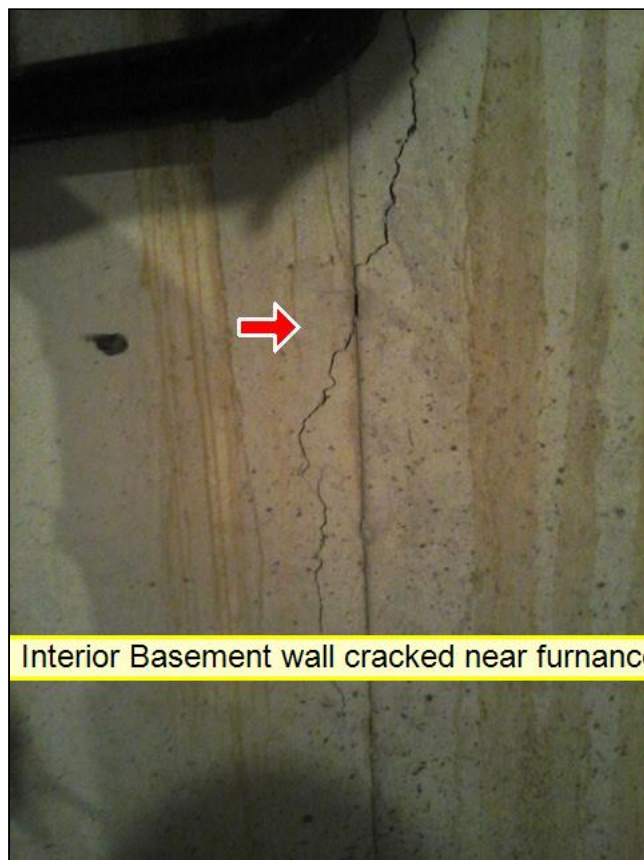
7.0 Item 3(Picture) Basement Wall crack

(3) Interior basement near furnace wall cracked. Repairs have been made to crack. HIGHLY recommend a NJ Registered Structural Engineer examine crack/repairs to determine structural integrity. Failure to do so may result in structural failure and or bodily harm to individual in the cause of a foundation failure. This is a MUST DO

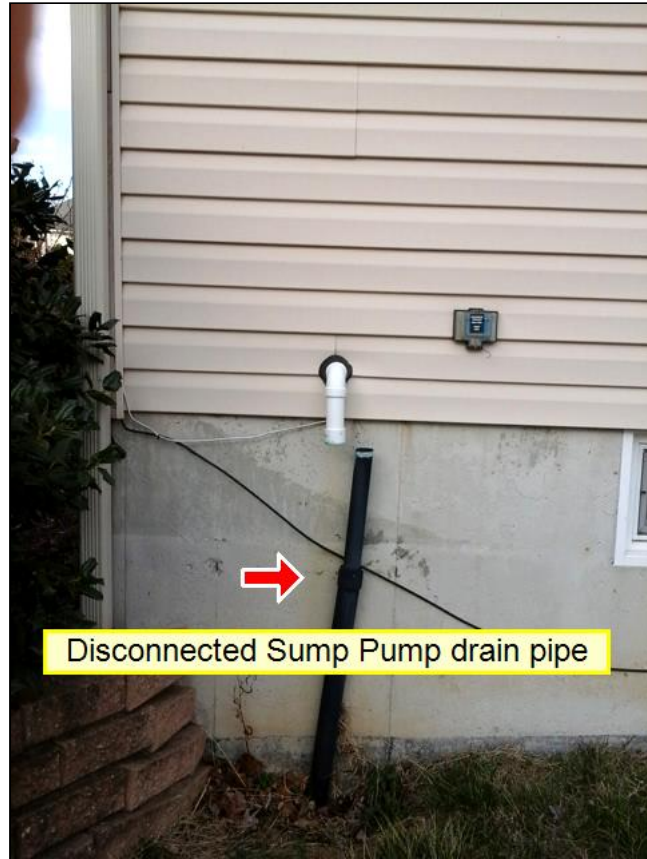
8.6 Item 1(Picture) Sump pump drain

Sump pump drain pipe disconnected on outside of structure. Recommend a NJ Licensed Plumber reattach the drain pipe to the sump pump outside. Failure to do so will result in water draining back towards the structure and cause potential water in the basement.

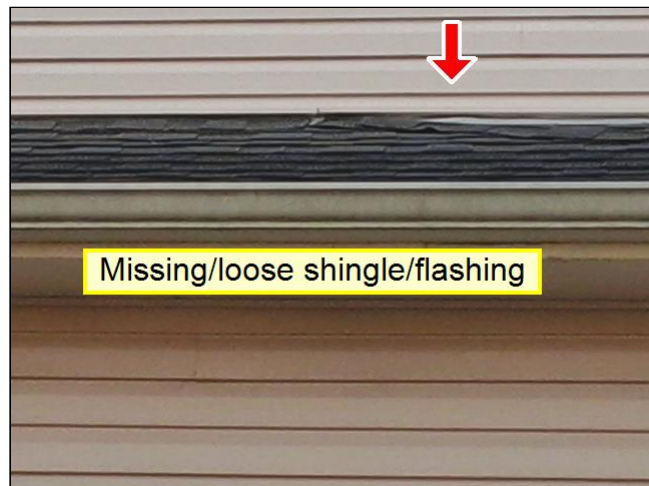
1.1 Item 1(Picture) Garage side siding

(1) Above Garage overhang- Shingles/Flashing material observed missing and loose. Recommend a NJ Registered Roofing Contractor repair and/or replace necessary shingle/flashing. Failure to do so may result in water leaking into structure ultimately cause water damage to structure.

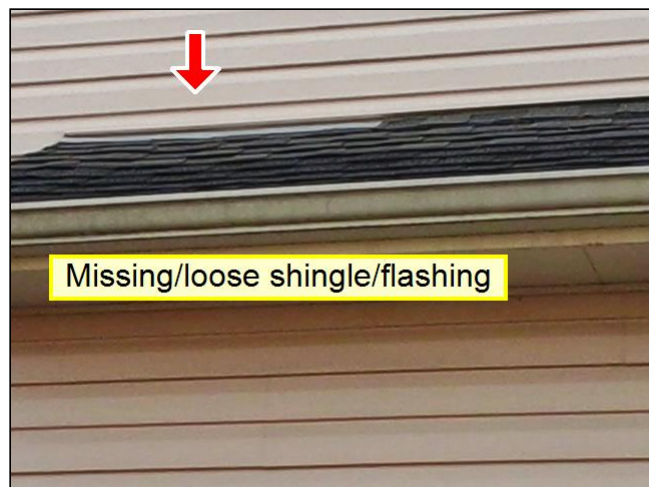
1.1 Item 2(Picture)

(2) Above Garage overhang- Shingles/Flashing material observed missing and loose. Recommend a NJ Registered Roofing Contractor repair and/or replace necessary shingle/flashing. Failure to do so may result in water leaking into structure ultimately cause water damage to structure.

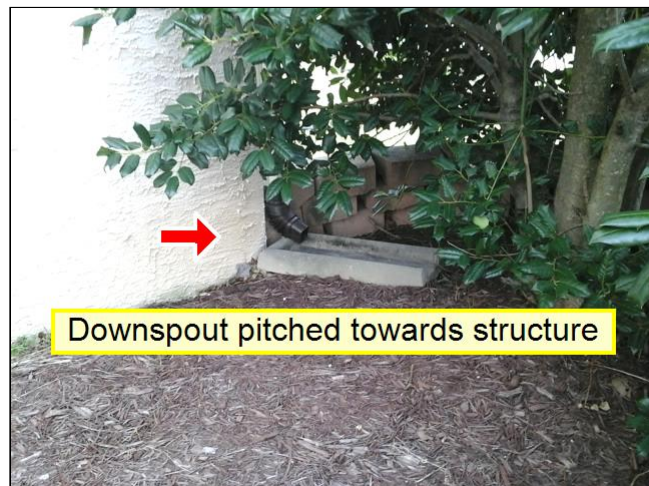
1.4 Item 1(Picture) Front Downspout

Front Right side of Structure-downspout pitched (leaning backwards) towards house. This is causing water to be diverted towards structure. Existing decorative brick structure has collapsed due to water diversion. Recommend that a NJ Registered Contractor reposition downspout to allow water to divert away from structure and repair decorative brick structure. Failure to do so will continue to cause decorative brick structure to collapse and ultimately pose a threat to water entering structure.

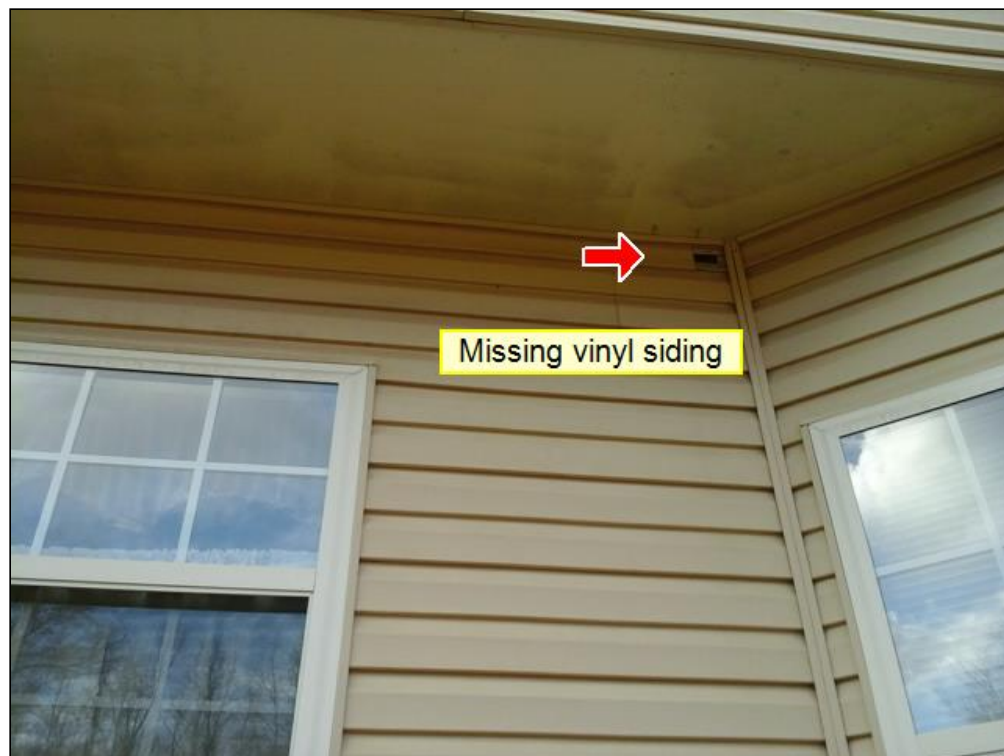
2.0 Item 1(Picture) Missing siding

Rear top of structure had missing piece of vinyl siding. Recommend NJ Registered contractor inspect and replace missing siding portion. Failure to do so will result in moisture getting behind siding and ultimately causing damage to structure possibly in form of rot or mold.

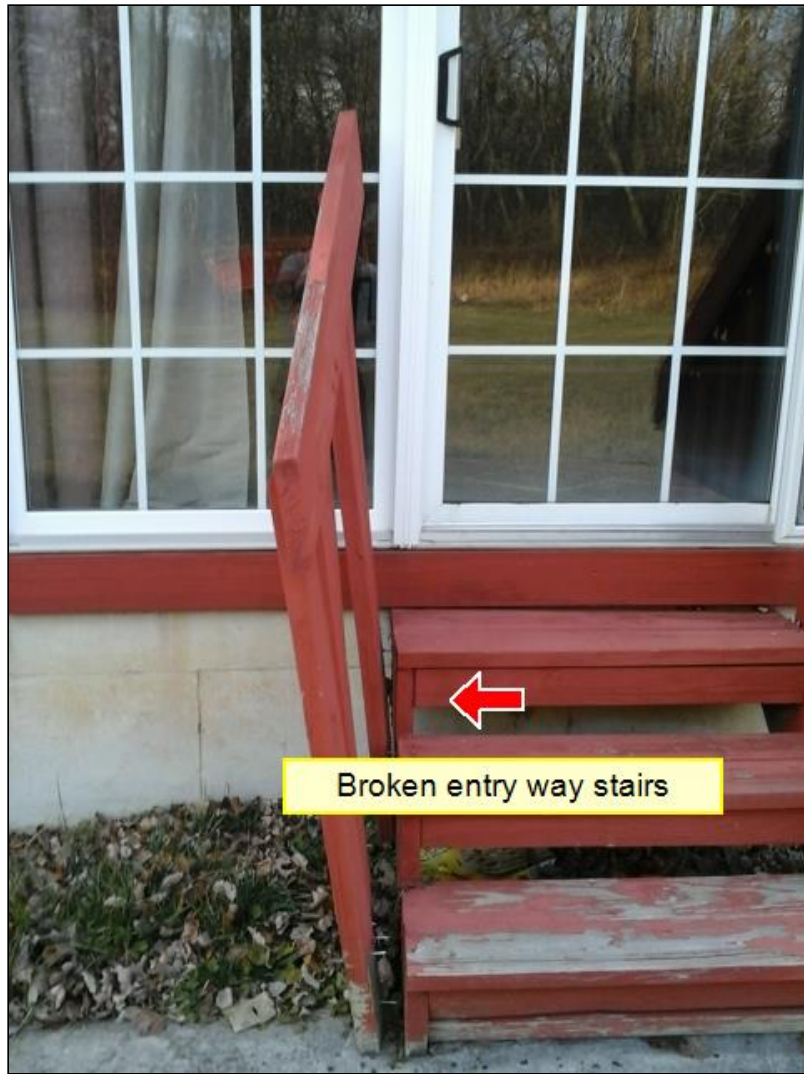
2.3 Item 1(Picture) Rear Steps

(1) Rear of structure had broken stairs into/exiting of home. HIGHLY Recommend at NJ Registered contractor repair/replace stairs. Failure to do WILL result in bodily harm. This is a MUST to do prior to using rear sliding door as an entry or exit mode.

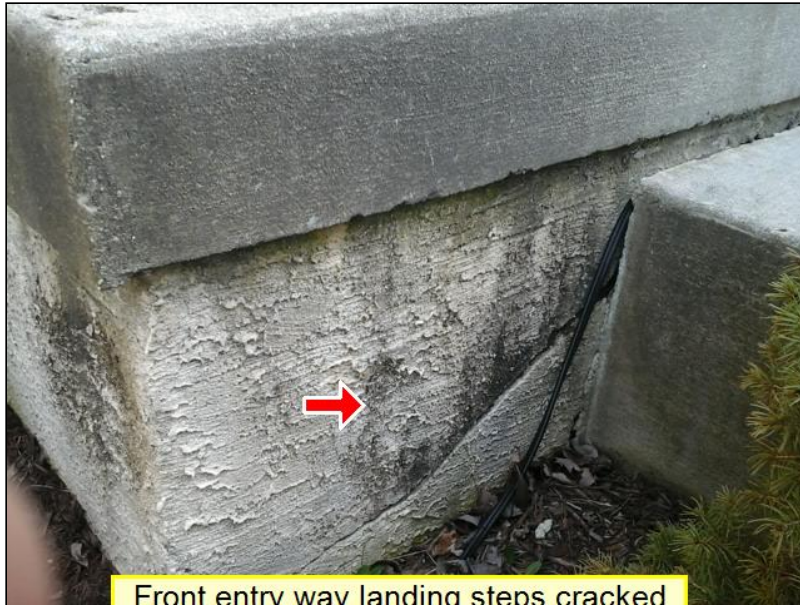
(2) Entry way steps/landing of structure cracked. Highly recommend a NJ Registered contractor make necessary repairs to steps/landing. Failure to do so may result in ultimate collapse of steps and could cause bodily harm to individuals. In addition, will allow moisture to potentially enter structure.

Front entry way landing steps cracked

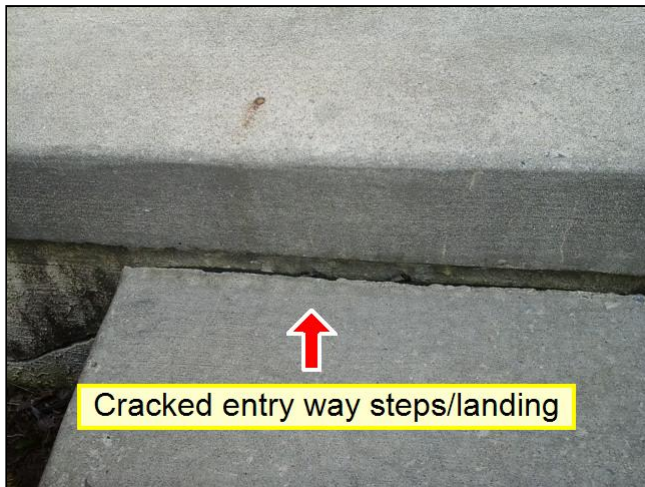
(3) Entry way steps/landing of structure cracked. Highly recommend a NJ Registered contractor make necessary repairs to steps/landing. Failure to do so may result in ultimate collapse of steps and could cause bodily harm to individuals. In addition, will allow moisture to potentially enter structure.

Cracked entry way steps/landing

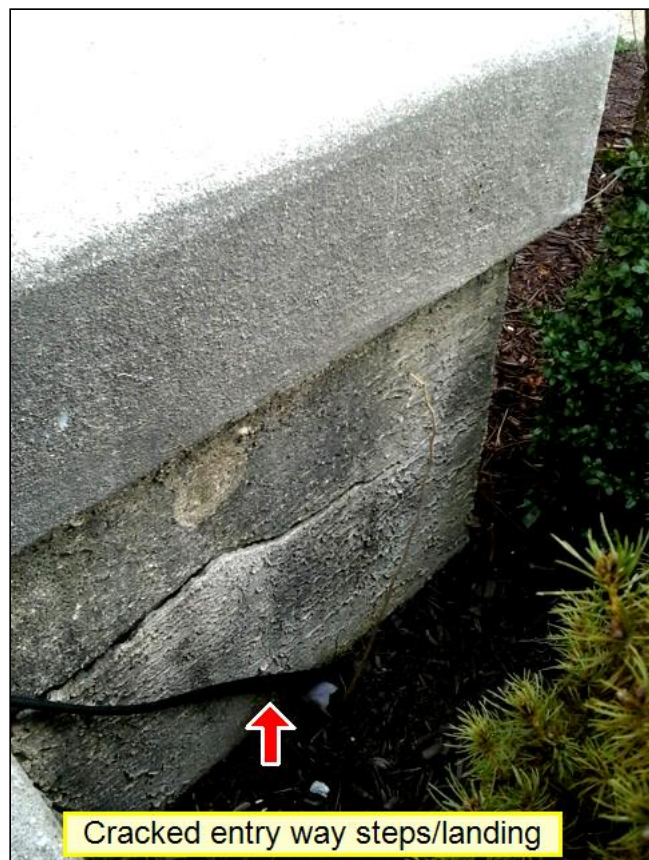
2.3 Item 4(Picture) Front Steps

(4) Entry way steps/landing of structure cracked. Highly recommend a NJ Registered contractor make necessary repairs to steps/landing. Failure to do so may result in ultimate collapse of steps and could cause bodily harm to individuals. In addition, will allow moisture to potentially enter structure.

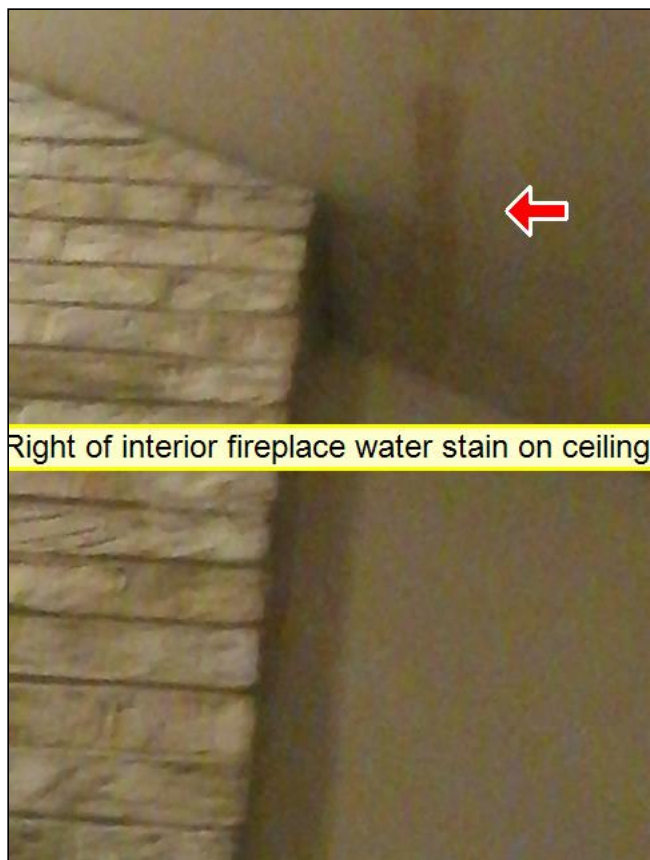
(1) Interior Fireplace right side on ceiling showed signs of water staining. Highly recommend that a NJ Registered Contractor examine cause of water stain and make necessary repairs. Failure to do so may result in additional staining and possible water damage to other parts of the structure.

Right of interior fireplace water stain on ceiling

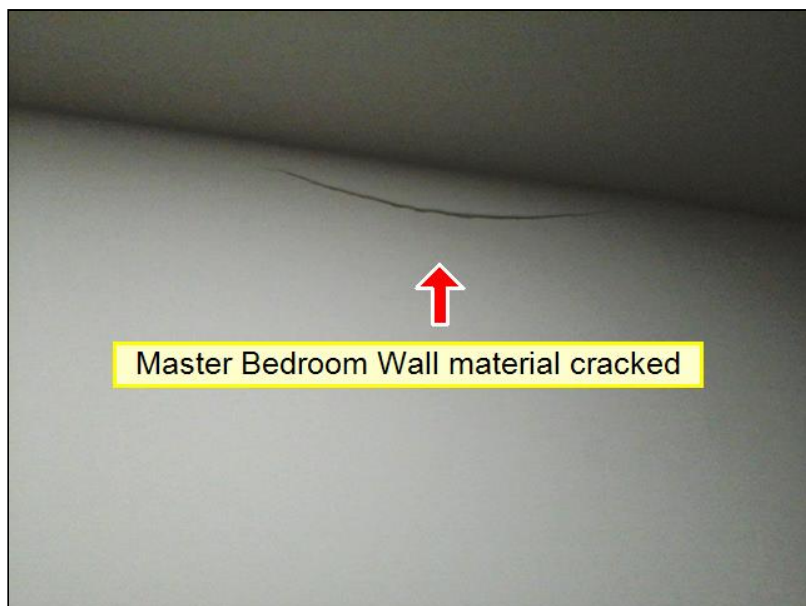
(2) Upstairs master bedroom wall has cracked drywall near ceiling. Highly recommend a NJ Registered Contractor examine cause of crack and make necessary repairs/replacement. Failure to do so may result in further damage to wall or structure.

Master Bedroom Wall material cracked

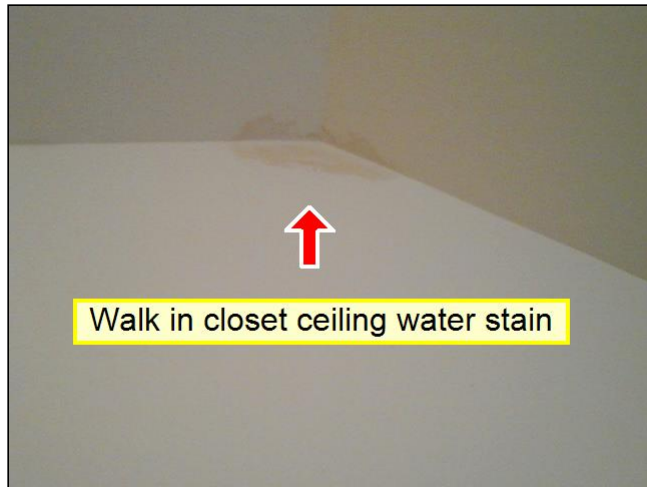
5.0 Item 3(Picture) Walk in Closet

(3) Upstairs walk in closet ceiling showed signs of water stain. Highly recommend a NJ Registered Contractor examine cause of crack and make necessary repairs/replacement. Failure to do so may result in further damage to wall or structure.

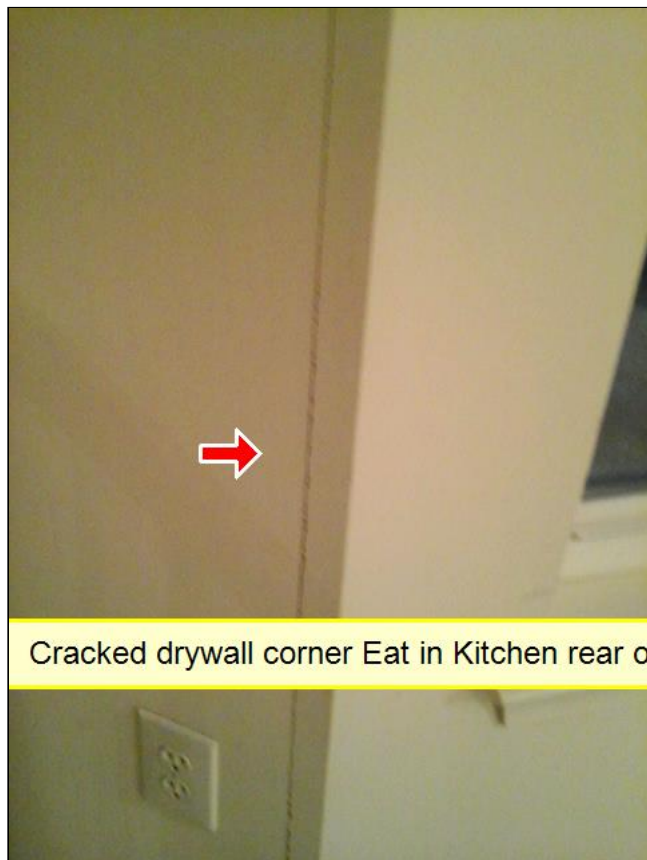
5.1 Item 1(Picture)

Drywall in Eat in Kitchen wall corner observed. Recommend a NJ Licensed Contractor examine and make necessary repairs to crack. Failure to do so may result in further cracking or structural damage to visibly unknown/unseen causes of crack.

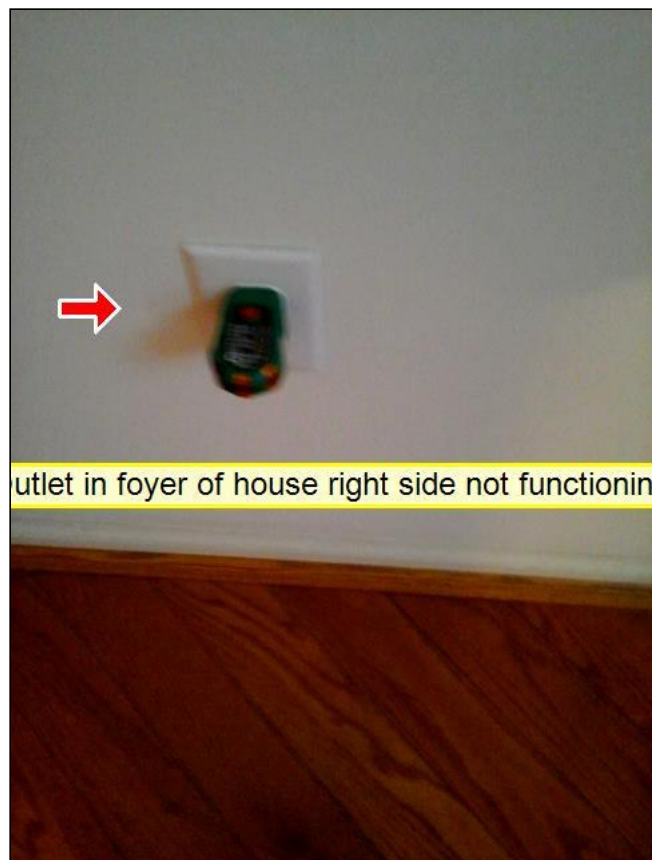
5.6 Item 1(Picture) Foyer Outlet

Outlet in foyer of structure not operational. Recommend a NJ Licensed Electrical Contractor repair/replace outlet. Failure to do so will cause lack of convenient use of outlet.

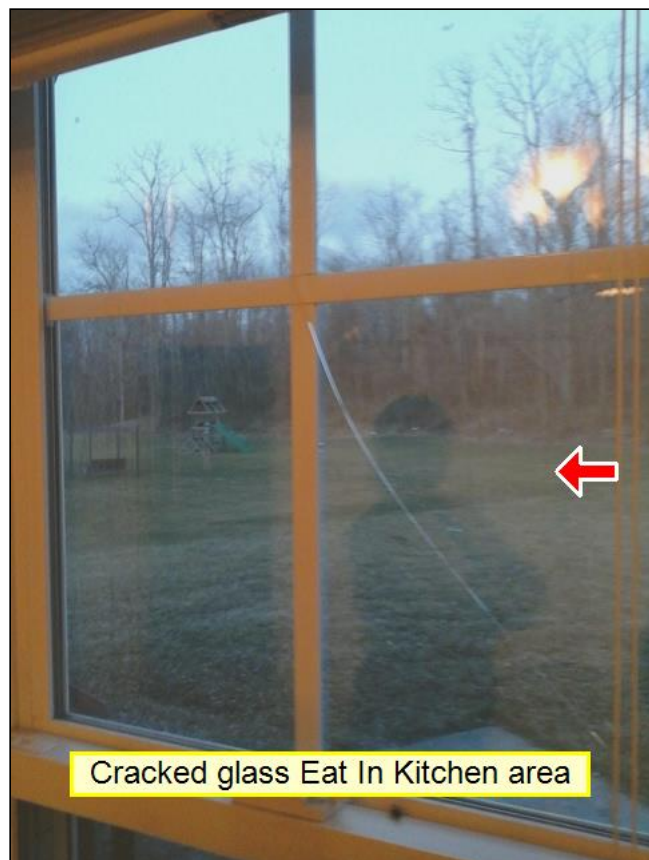
6.2 Item 1(Picture) Cracked glass in Kitchen

Cracked glass panel in eat in kitchen window. Recommend a NJ Registered contractor replace window/window glass. Failure to do so may result in glass cracking more and or bodily harm if glass cuts an individual.

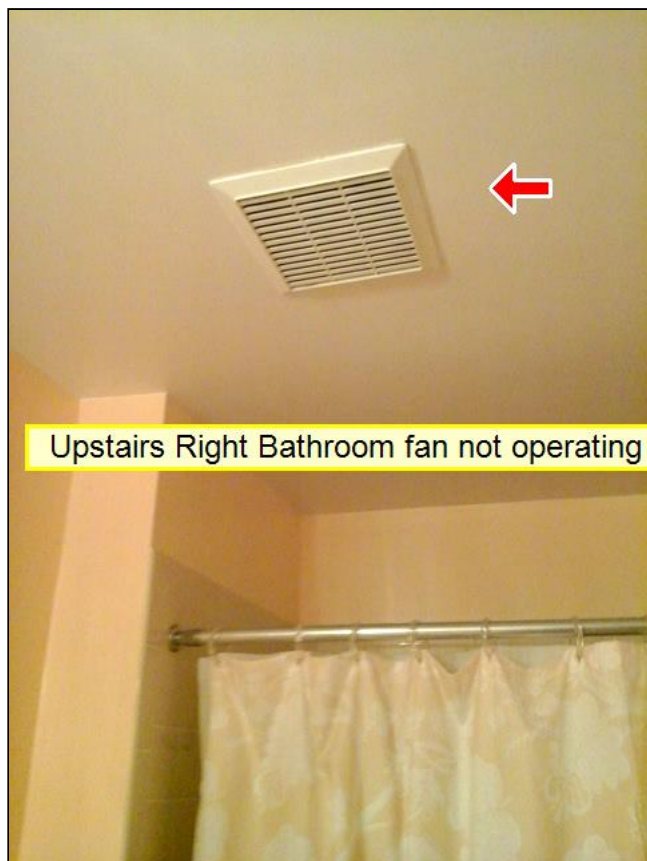
6.6 Item 1(Picture) Bathroom Fan

Upstairs Right bathroom not operating. Recommend a NJ Licensed Electrical Contractor make necessary repairs. Failure to do so will result in moisture from shower not being vented out of structure ultimately leading to possible mold development.

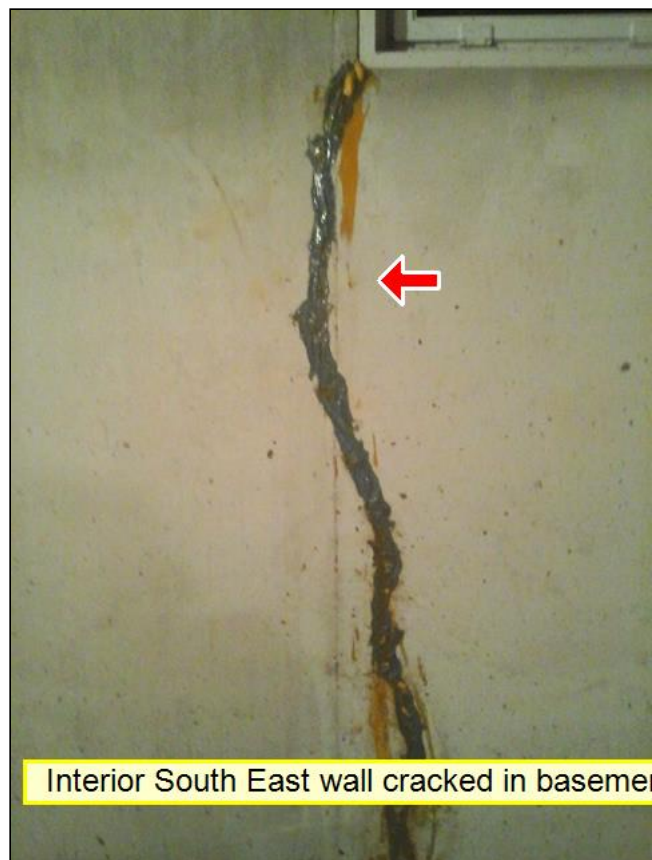
7.0 Item 2(Picture) Basement Wall Crack

(2) Interior basement wall cracked. Repairs have been made to crack. HIGHLY recommend a NJ Registered Structural Engineer examine crack/repairs to determine structural integrity. Failure to do so may result in structural failure and or bodily harm to individual in the cause of a foundation failure. This is a MUST DO

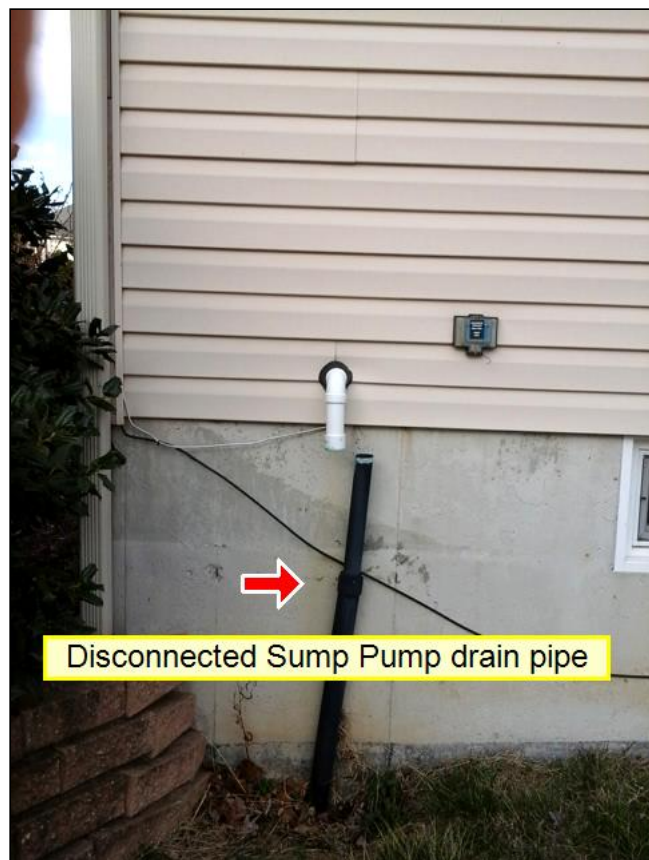
8.6 Item 1(Picture) Sump pump drain

Sump pump drain pipe disconnected on outside of structure. Recommend a NJ Licensed Plumber reattach the drain pipe to the sump pump outside. Failure to do so will result in water draining back towards the structure and cause potential water in the basement.

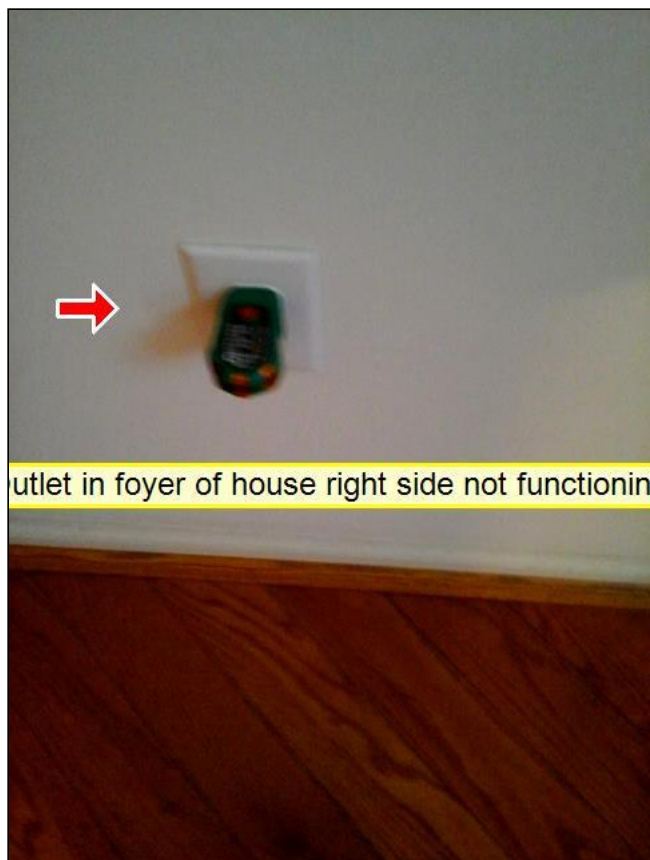
5.6 Item 1(Picture) Foyer Outlet

Outlet in foyer of structure not operational. Recommend a NJ Licensed Electrical Contractor repair/replace outlet. Failure to do so will cause lack of convenient use of outlet.

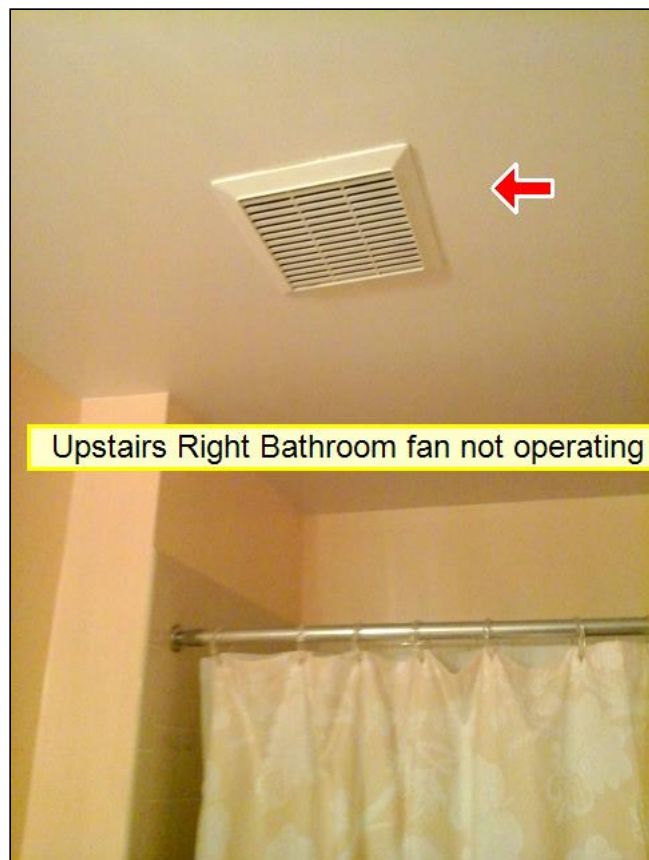
6.6 Item 1(Picture) Bathroom Fan

Upstairs Right bathroom not operating. Recommend a NJ Licensed Electrical Contractor make necessary repairs. Failure to do so will result in moisture from shower not being vented out of structure ultimately leading to possible mold development.
