# Inspection Report

123 Whisper Lane  
Ocean NJ 07763

**Integrity Home Inspection Services Group LLC.**

<b>Date:</b> 2/20/2017	<b>Time:</b> 12:00 PM	<b>Report ID:</b> 052917
<b>Property:</b> 123 Whisper Lane Ocean NJ 07763	<b>Customer:</b> Mrs. Lisa Johnson	<b>Real Estate Professional:</b>

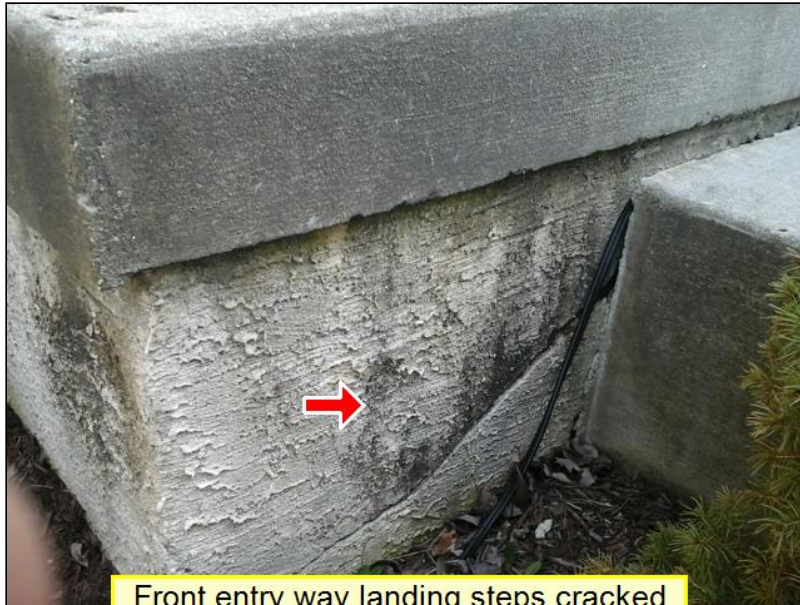
Front entry way landing steps cracked

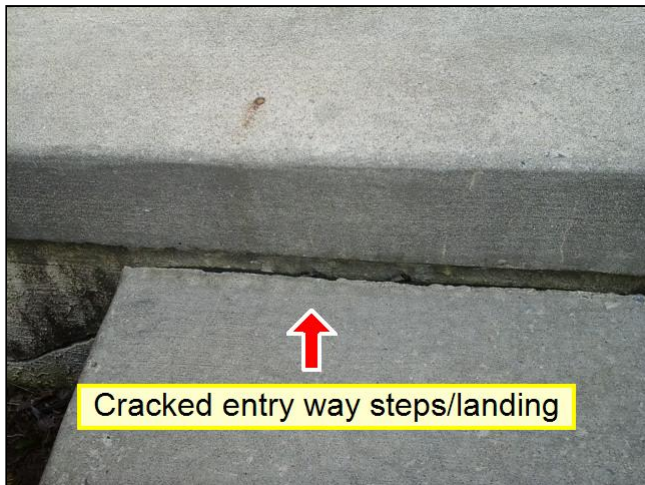
Cracked entry way steps/landing

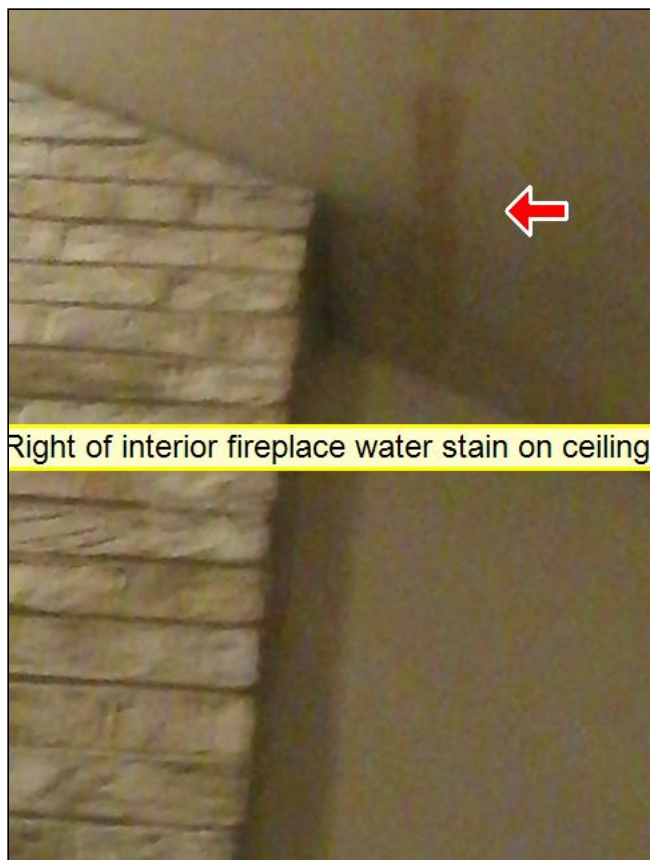
Right of interior fireplace water stain on ceiling

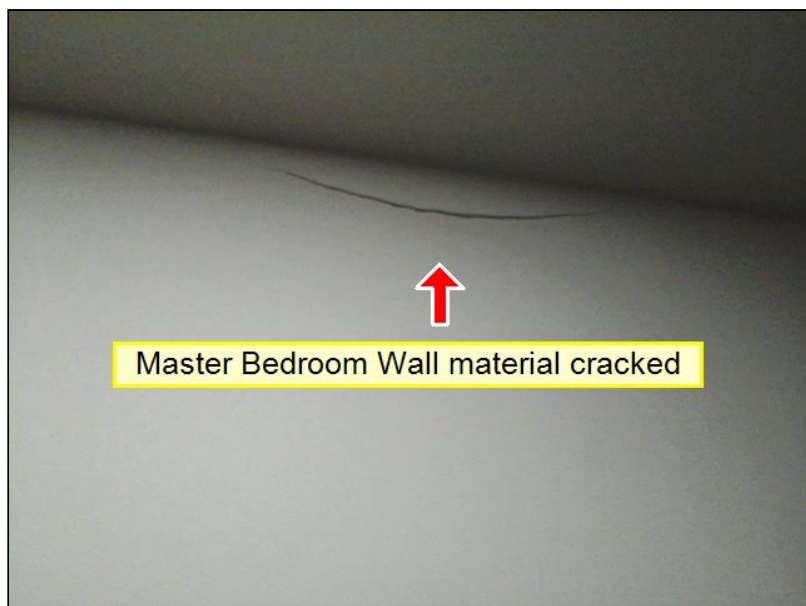
Master Bedroom Wall material cracked
